WHAT LIES

By David Tamblyn BSc Hons, MWMSoc. MD of Envirosafe UK Ltd. A study into the long term benefits of Glass R

GRP Reinforced Plastic (GRP) Cold Water Storage Tanks (CWST) and the efficacy of current cleaning practices

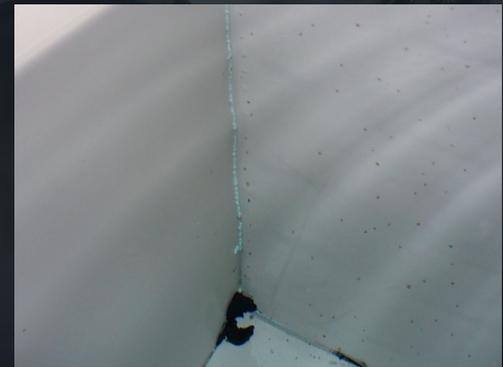
Whilst removing the cysts from the sides of tanks for examination, it was noted that the cysts usually coincided with a raised "blister" area on the surface of the GRP. These blisters on the tank surface led us to believe that the cysts were actually growing out from the damaged surface of the tank.

Cysts growing on right panel of a sectional tank, note the left panel is clear.

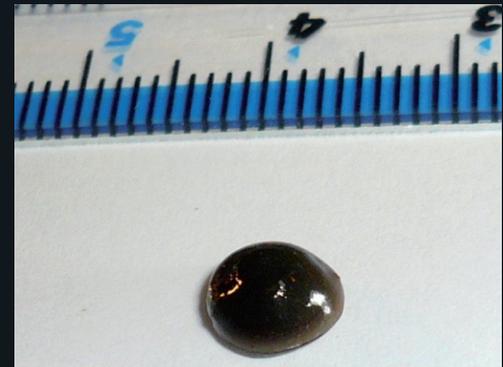
Cyst on a microscope slide

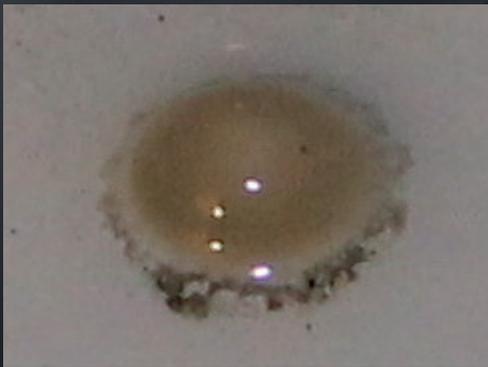
Close-up of a cyst on the surface of a GRP Tank

The visible blistering on the surface of the GRP surface is also known as osmosis, and this phenomenon has been well documented, with regard to fibreglass boats and yachts, for many years.

In relation to the size of a water molecule, bacteria are huge (approximately 100,000 times larger), therefore bacteria cannot normally penetrate a GRP Gel coating. However, as the osmotic pressure builds up inside the blister, the Gel coating is stretched and finally cracks. These cracks provide the perfect habitat for the establishment of a biofilm.

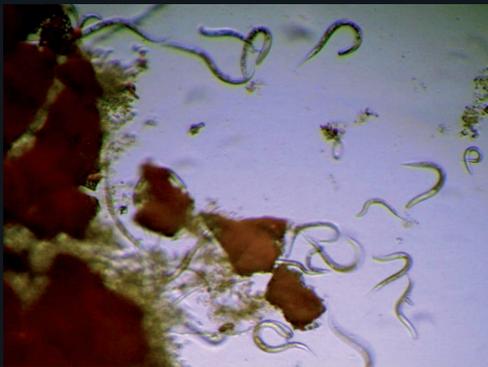
Nematode worms x40
